This Report Has Been Prepared Exclusively For: Linda Wyman

Property Address: 3900 W Hooker, Seattle, WA
Date of Inspection: 3/24/2007 Start Time: 3:15:00 PM Report Number: 032407-3

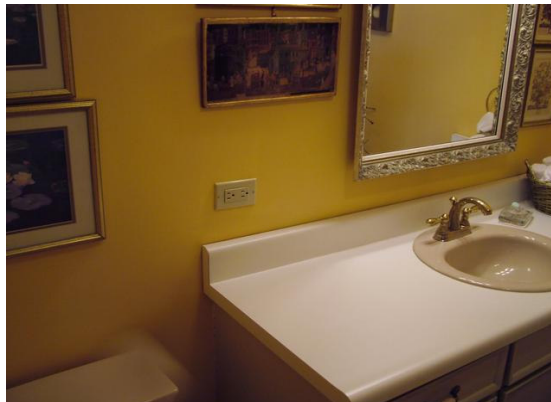
Photo: 6560.01 (1)

[F] 6560.01: GFCI outlet not installed.
See series 6560.01 photo(s)

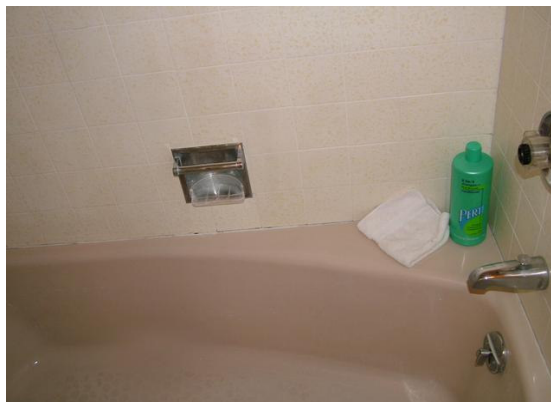
Photo: 6770.04 (1)

[F] 6770.04: General caulking and sealing needed.

See series 6770.04 photo(s)
