This Report Has Been Prepared Exclusively For: Linda Wyman

Property Address: 3900 W Hooker, Seattle, WA
Date of Inspection: 3/24/2007 Start Time: 3:15:00 PM Report Number: 032407-3

Structure Survey Findings:

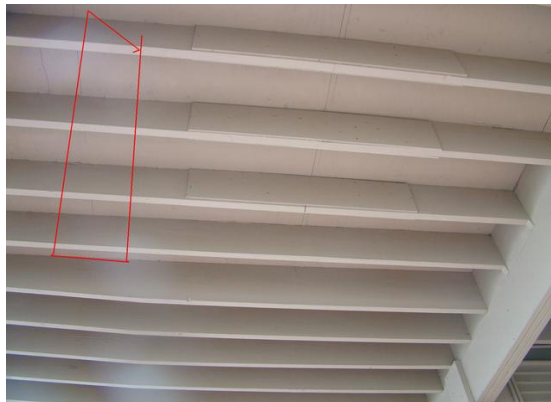
Photo: 9200.01 (1)

[F] 9200.01: Upper deck has been extended using gussets. Recommend review by structural engineer advised.

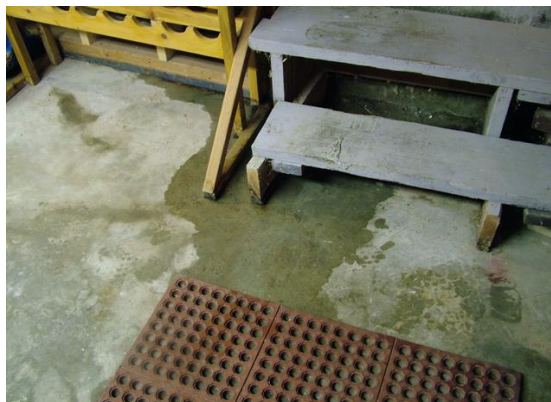
Photo: 9400.01 (1)

[R] 9400.01: Prior or present moisture noted in the basement area. Recommend review by water proofing contractor to determine cause and costs to repair.

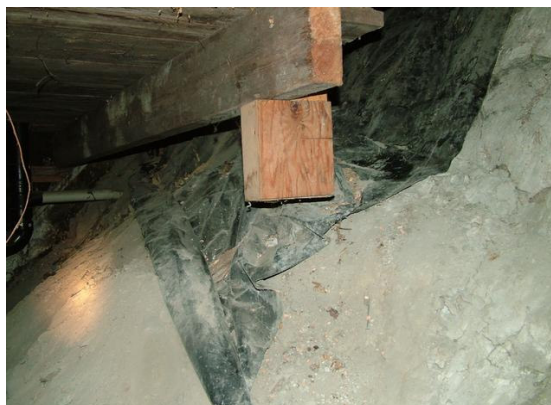
Photo: 9800 (1)

[R] 9800: Review of entire structure by a structural engineer advised before purchasing property.

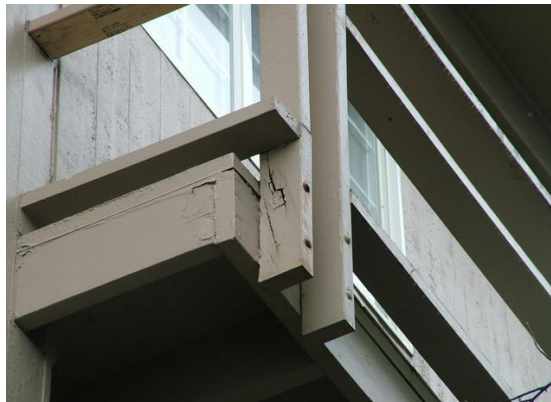
Photo: 9840 (1)

[F] 9840: Wood deterioration noted on building member. Deck rail rotted on upper deck.

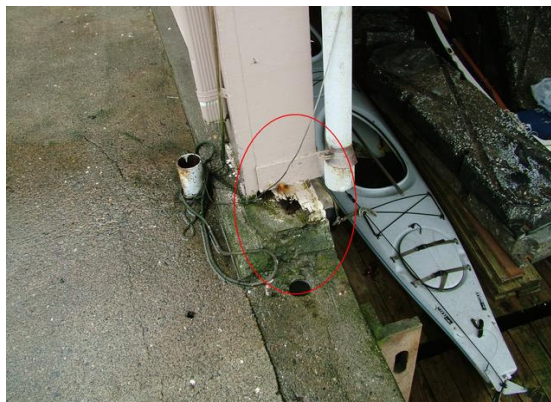
Photo: 9840 (2)

[F] 9840: Wood deterioration noted on building member. See series 9840 photo(s)
